Report on the investigation of a local bump, Brookside

mine, Kentucky Jellico Coal Co., Ky., November 2, 1962,

Coal outbursts in K main section, Brookside mine, Kentucky Jellico Coal Company, Incorporated, Brookside, Harlan County, Kentucky, November 2 and 3, 1962

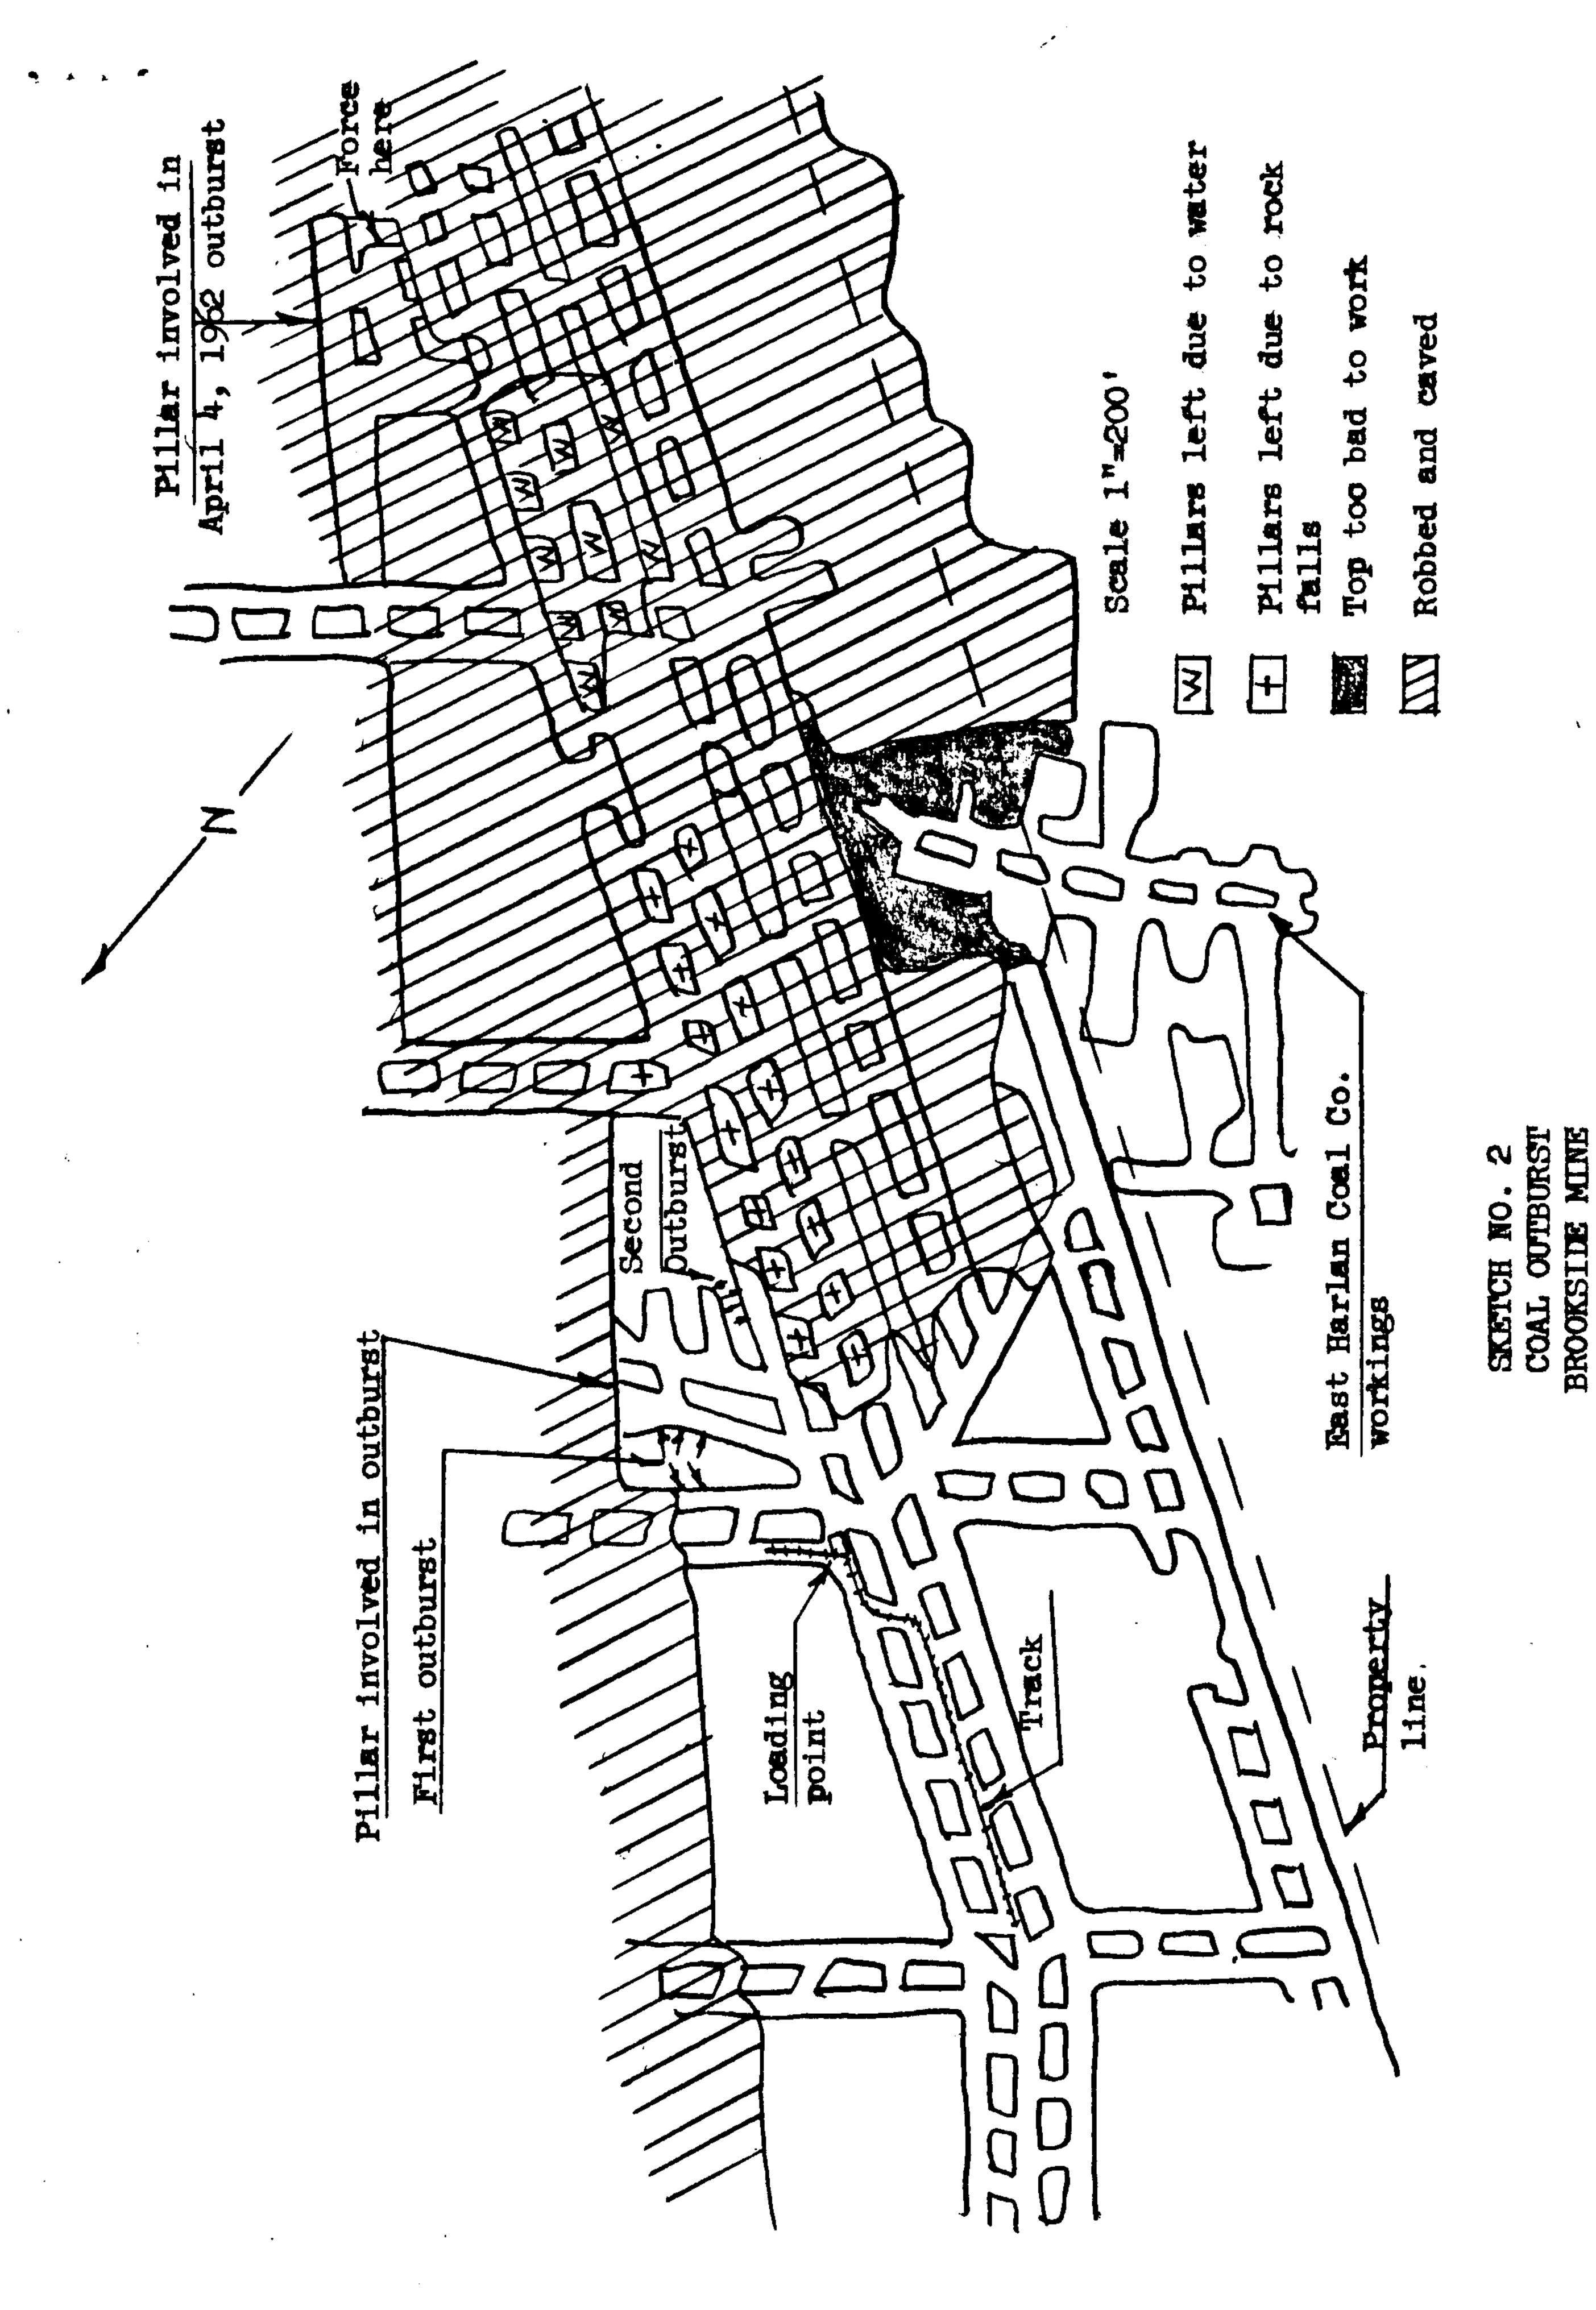
KENTUCKY JELLICO COAL COMPANY, INCORPORATED NOVEMBER 2, 1962

All mining in K main section was confined to the recovery of entry chain pillars and the flanking barrier pillars (see sketch No. 2). The barrier pillars, formed during the development of the K main section, were of decidedly unequal deminsions and each one created a different problem during extraction.

The outbursts were caused by driving splits toward the caved areas in a highly stressed coal pillar. Driving the splits without spads which resulted in forming a large pillar point on the gob end of the remnant was a contributing factor (see sketch No. 1).

1. The pillars should be recovered by the open-end lift method; however, where roof conditions present a hazard, a thin wing or fender is permissible. The lifts should be driven so that each lift and adjacent consecutive lifts will be mined along the gob sides of the pillars. Only one lift, not more than 16 feet wide, should be mined at one time.

2. Pillar splits should not be driven without spads or to excessive widths into a pillar so as to cause the pillar to be "pushed out" instead of being extracted from the gob side.
